Issue Paper

Refrigerated Container (Reefer) Explosion

Revised Information Regarding Counterfeit Refrigerant

Guide to testing R-134a cylinder contents for Chlorine Contamination

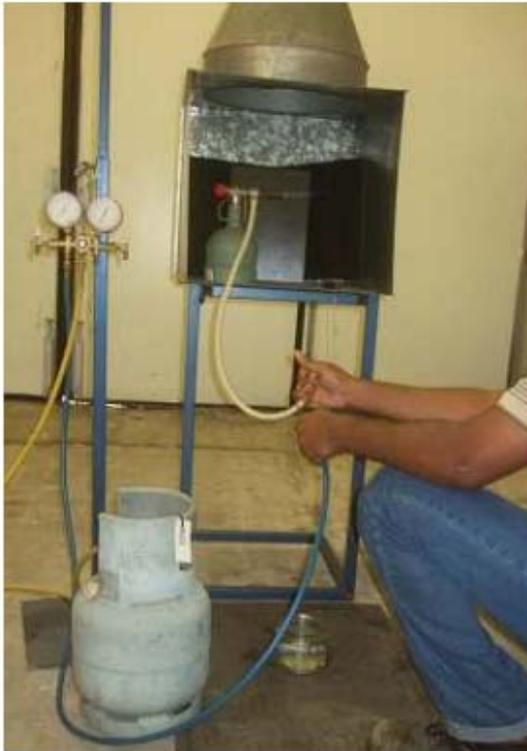
To minimise the risks associated with the product of degradation fumes, fabricate a fume cupboard using an enclosure and extractor fan.

Vessels and depots could use existing air extraction devices such as welding or exhaust extractors.

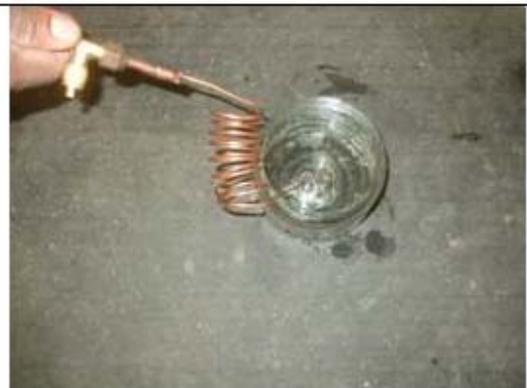
To minimise the risks associated with flammable gases and to comply with F- gas regulations, use a set of manifold service gauges and a capillary tube as shown. After purging the lines, bubble the gas through some water to ensure the flow rate is minimal. Just a few bubbles will suffice, as the test is very sensitive.

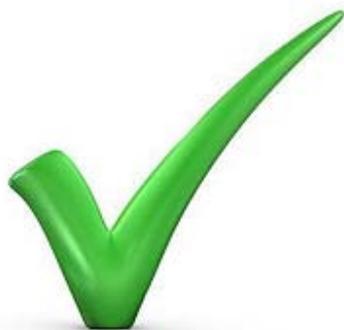
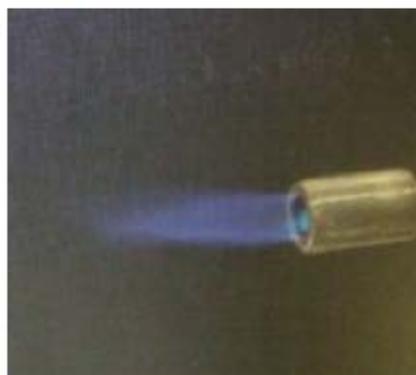
OK ! Blue flame = R134a

This test will detect if there are chlorine contaminants in the refrigerant, sensitivity 300ppm (parts per million). HFC-134a is fluorinated and does not change the colour of the flame. A green flame indicates the presence of chlorine. Eg. R-22 will show a green flame because it contains chlorine. Halide detectors were commonly used by service engineers for more than twenty years but became obsolete when chlorine free refrigerants, (like R134a), were introduced.

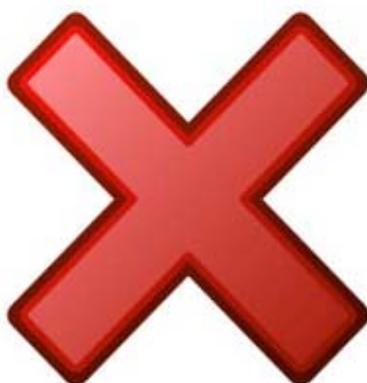
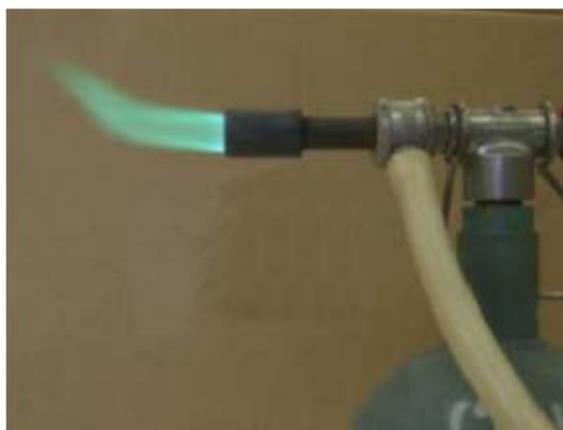
Bad ! Green flame = contamination

Any refrigerant bottles marked as HFC-R134a that show a green flame should be quarantined and NOT USED.

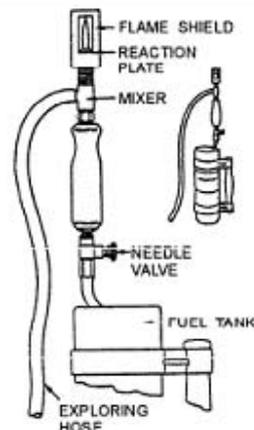
The use of a halide leak detector is the most positive method of detecting chlorine containing refrigerants, sensitivity about 300ppm. Such a detector consists essentially of a torch burner, a copper reactor plate, and a rubber exploring hose.

Refrigerant gas suspected of containing chlorine is drawn through the hose into the torch burner of the detector. Here the air passes over the copper reactor plate, which is heated to incandescence. If there is a minute trace of a chlorine refrigerant present, the colour of the torch flame changes from blue (neutral) to green as the chlorine containing refrigerant contacts the reactor plate. The shade of green depends upon the amount of halogen refrigerant; a pale green colour shows a small concentration and a darker green colour, a heavier concentration.

Please note a standard blowtorch cannot be used, as the copper reaction plate is required.
